PERFORMANCE OF INCONEL 550 TURBINE BLADES
IN A TURBOJET ENGINE AND EFFECTS OF
DIFFERENT FORGING TEMPERATURES
AND HEAT TREATMENTS

By C. A. Gyorgak, J. R. Johnston, and J. W. Weeton

Lewis Flight Propulsion Laboratory
CLASSIFICATION CHANGED Cleveland, Ohio

August 16, 1955

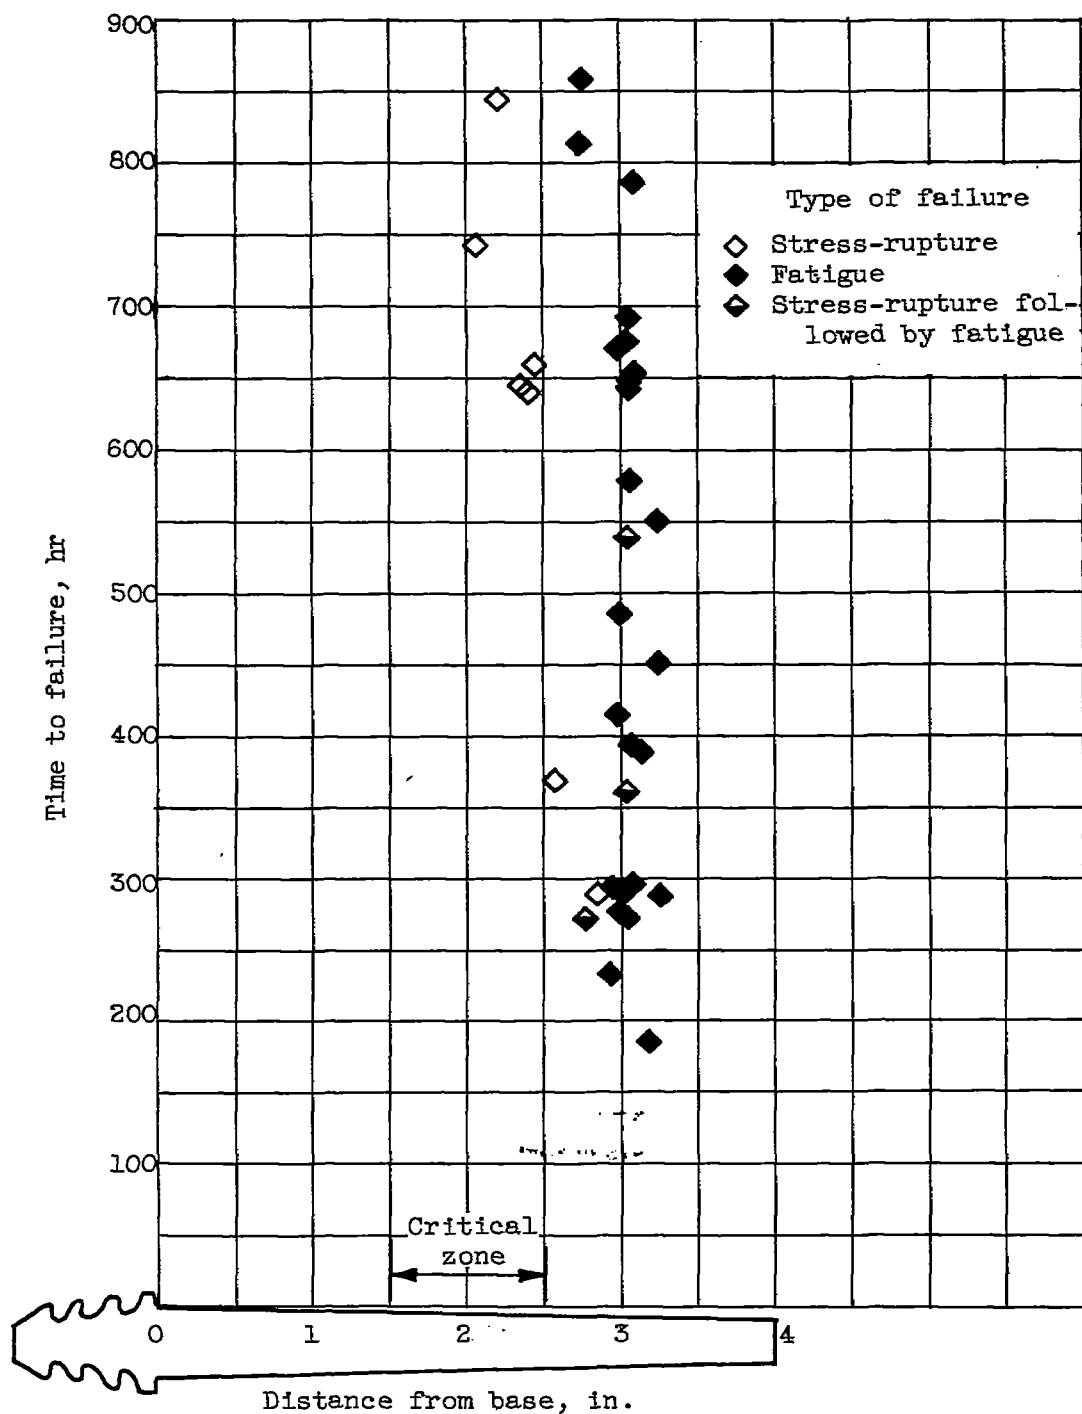
Figure 13. - Occurrence of failures in Inconel 550 with respect to blade length. Damage failures excluded.

Of the six groups tested, all first failures occurred by fatigue, five of them occurring in the leading edge approximately 3 inches above the base and the other originating in the trailing edge, also approximately 3 inches above the base. The last failures occurred as follows: two by fatigue, one by stress rupture followed by fatigue, and three by stress rupture. Failures from fatigue and from stress rupture followed by fatigue originated in the leading edge, high in the airfoil, while the stress-rupture failures originated away from the leading or trailing edge of the blade and occurred within the critical zone.
